“LUBRICATING OIL ANALYSIS”

Immersion experiment report

Laboratory SGS-CSTC Standards Technical Services (Shanghai) Co., Ltd
OGC Shanghai Test Centre-Lube Lab
Report date 17th Apr. 2024

Report No: S024-03766

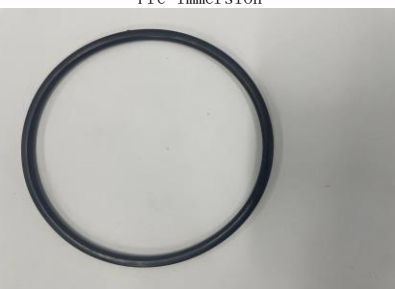
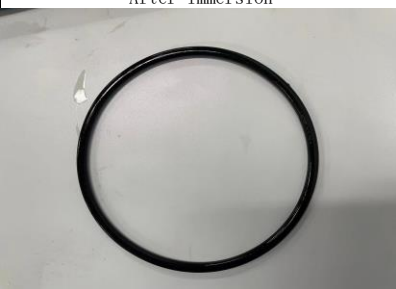
Material name:O-Ring		
Sample name:Shell320+1%W100		
Test condition:After 72h of immersion at room temperature, visually inspect the surface of the test piece under natural light.		
Pre-immersion	After immersion	Immersion results

No significant changes in appearance
Material name:O-Ring		
Sample name:Mobil320+1%W100		
Test condition:After 72h of immersion at room temperature, visually inspect the surface of the test piece under natural light.		
Pre-immersion	After immersion	Immersion results

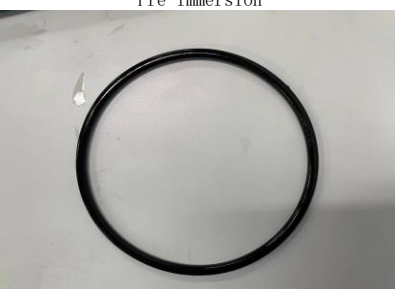
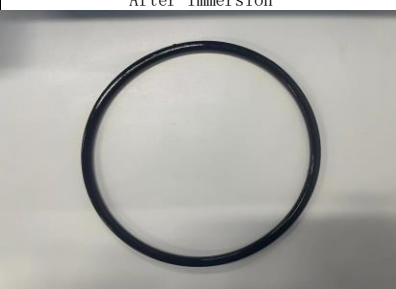
No significant changes in appearance
Material name:O-Ring		
Sample name:Fuchs320+1%W100		
Test condition:After 72h of immersion at room temperature, visually inspect the surface of the test piece under natural light.		
Pre-immersion	After immersion	Immersion results

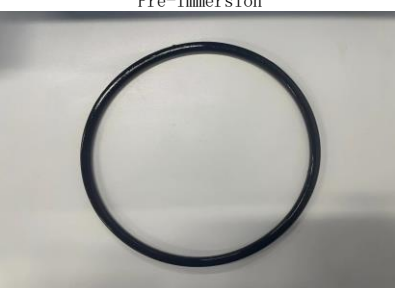
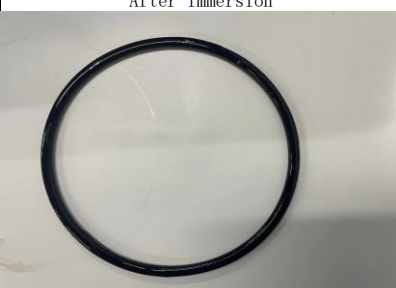
No significant changes in appearance
Material name:O-Ring		
Sample name:Castrol320+1%W100		
Test condition:After 72h of immersion at room temperature, visually inspect the surface of the test piece under natural light.

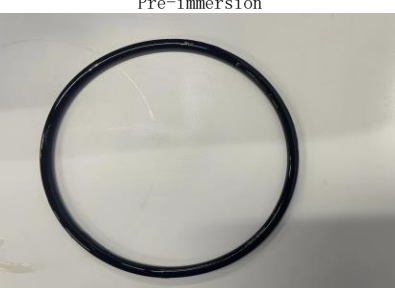
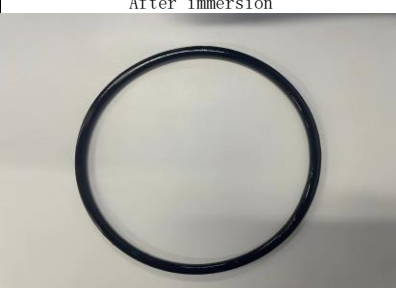
No significant changes in appearance

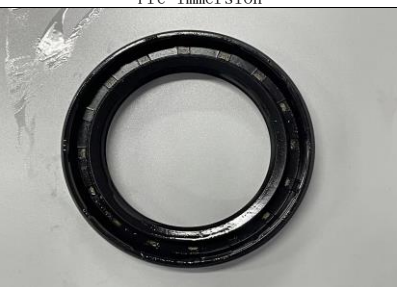
Material name:Seal		
Sample name:Shell320+1%W100		
Test condition:After 72h of immersion at room temperature, visually inspect the surface of the test piece under natural light.		
Pre-immersion	After immersion	Immersion results
 	 	No significant changes in appearance
Material name:Seal		
Sample name:Mobil320+1%W100		
Test condition:After 72h of immersion at room temperature, visually inspect the surface of the test piece under natural light.		
Pre-immersion	After immersion	Immersion results

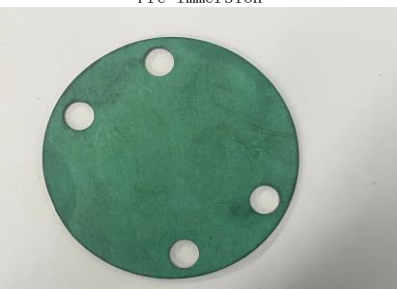
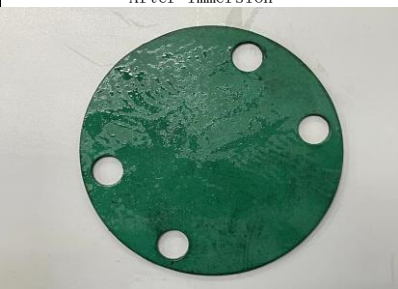
Material name:Thrust washer		
Sample name:Shell320+1%W100		
Test condition:After 72h of immersion at room temperature, visually inspect the surface of the test piece under natural light.		
Pre-immersion	After immersion	Immersion results

No significant changes in appearance
Material name:Thrust washer		
Sample name:Mobil320+1%W100		
Test condition:After 72h of immersion at room temperature, visually inspect the surface of the test piece under natural light.		
Pre-immersion	After immersion	Immersion results

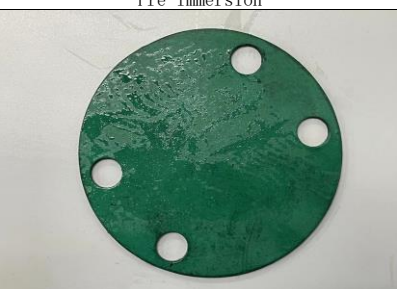
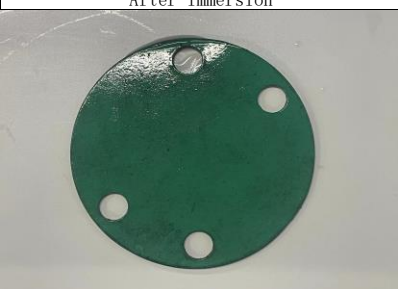
No significant changes in appearance
Material name:Thrust washer		
Sample name:Fuchs320+1%W100		
Test condition:After 72h of immersion at room temperature, visually inspect the surface of the test piece under natural light.		
Pre-immersion	After immersion	Immersion results

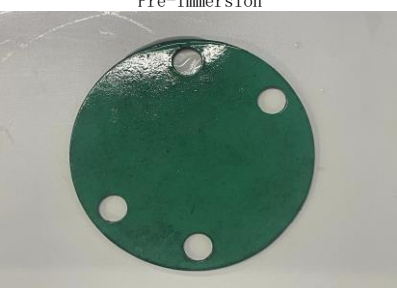
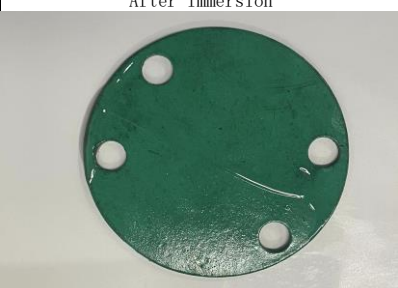
No significant changes in appearance
Material name:Thrust washer		
Sample name:Castrol320+1%W100		
Test condition:After 72h of immersion at room temperature, visually inspect the surface of the test piece under natural light.

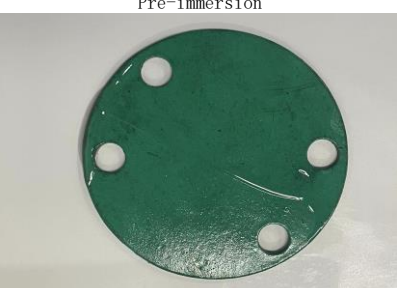
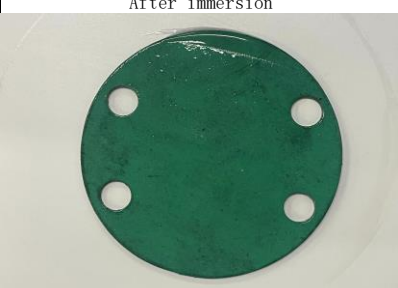
No significant changes in appearance

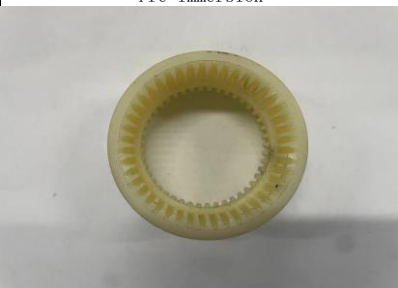
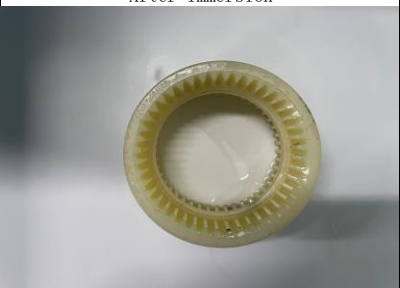
Material name:BoWex 38M Nylon		
Sample name:Mobil320+1%W100		
Test condition:After 72h of immersion at room temperature, visually inspect the surface of the test piece under natural light.		
Pre-immersion	After immersion	Immersion results

No significant changes in appearance
Material name:BoWex 38M Nylon		
Sample name:Fuchs320+1%W100		
Test condition:After 72h of immersion at room temperature, visually inspect the surface of the test piece under natural light.		
Pre-immersion	After immersion	Immersion results

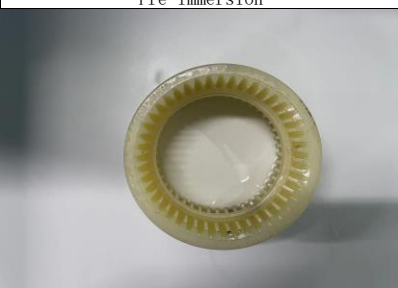
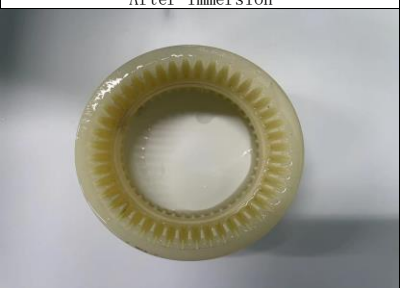
No significant changes in appearance
Material name:BoWex 38M Nylon		
Sample name:Castrol320+1%W100		
Test condition:After 72h of immersion at room temperature, visually inspect the surface of the test piece under natural light.		
Pre-immersion	After immersion	Immersion results

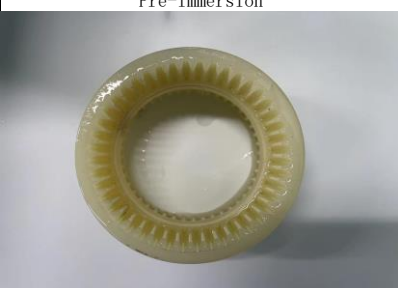
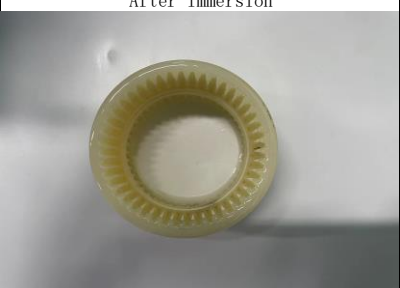
No significant changes in appearance
