Higher Efficiency and Longer Service Life for Gears and Bearings - Wind

REWITEC GmbH
Dr.-Hans-Wilhelmi-Weg 1
35633 Lahnau
Germany

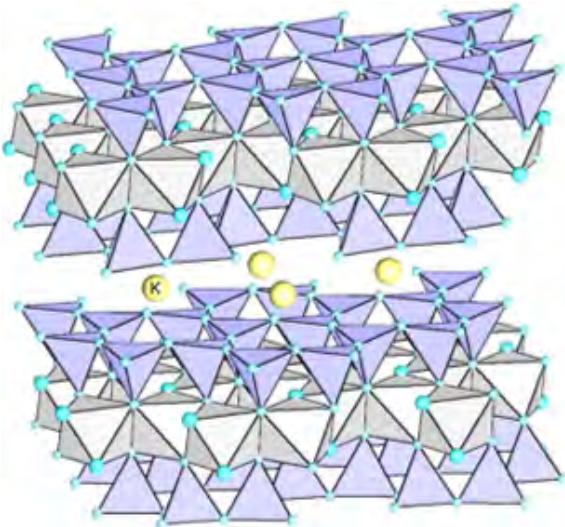
Phyllosilicate Based Particle Additives

- Platelet-shaped particles with layered crystal structure
 - Si-O and Al-O based layers
 - Strong *covalent* bonds within the layer
 - Weak *van der Waals* interaction between the layers
- Easy shearing between the layers
 - **Friction reduction**
- Big specific area with high adsorption ability
 - covering the surface, filling the holes
 - **Protective, repairing and smoothing effect**
- Particle size $d_{90} = 4 \mu\text{m}$
- Soft material: Mohs Hardness Scale 2.5 (like fingernail!)

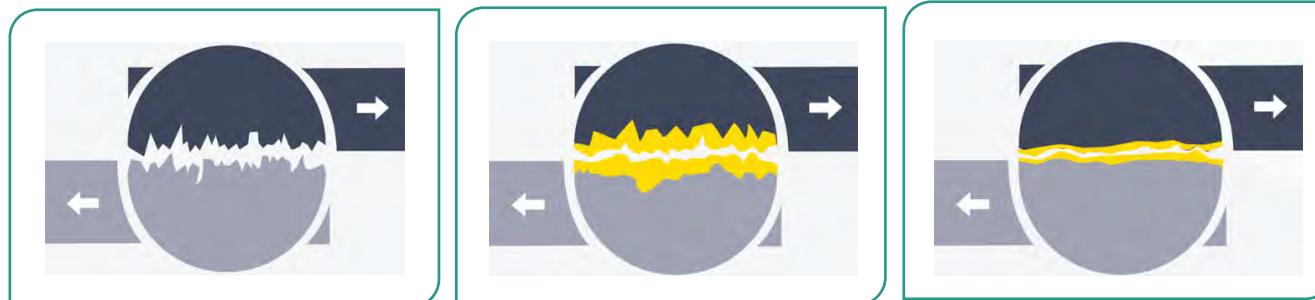
Mechanism of Action

Step 1

Step 2

Step 3

Significant reduction of friction, wear, roughness and temperature

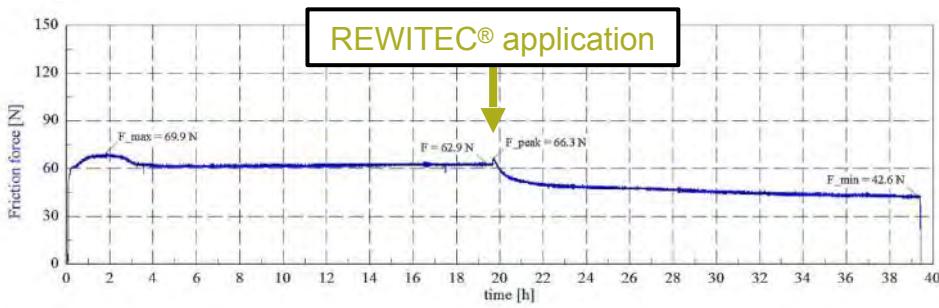
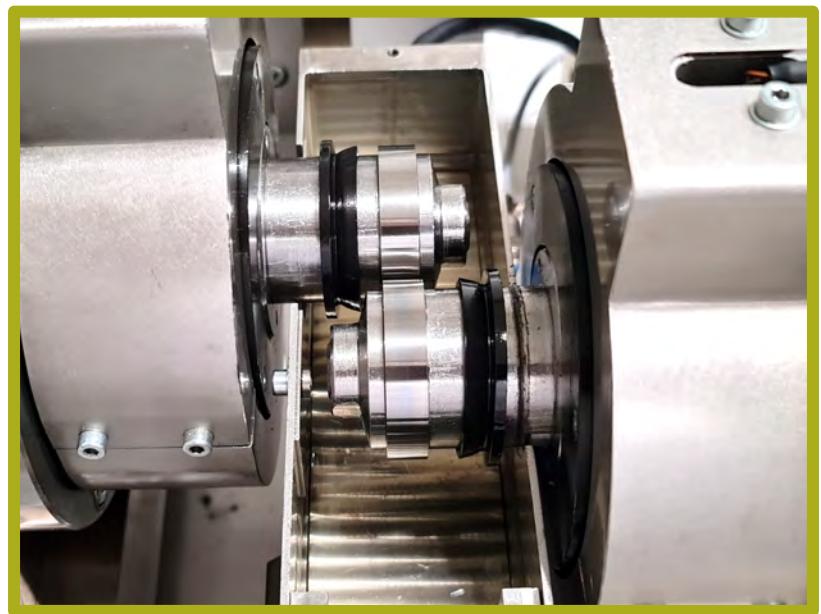
2-Disc Assembly Rolling Wear Test – Gear Oils

Reduction in friction

- Stress value: 1 GPa (normal force 2150 N)
- Rotating speed: 424 rpm / 339 rpm, slip 20 %
- Test-duration: 39,3 h
- Temperature: oil inlet temperature 60 °C
- Friction coefficient: μ =normal force/friction force

Castrol Optigear Synthetic X320

Oil	Friction reduction	Roughness reduction
Castrol Optigear Synthetic X320	33 %	41 %
Mobilgear SHC XMP 320	35 %	44 %
Klübersynth GEM 4-320N	40 %	54 %
Fuchs Unisyn CLP 320	36 %	50 %
Amsoil PTN 320	46 %	18 %
Shell Omala S4 GX 320	42 %	25 %
Klüüberbio EG 2-150	55 %	40 %
Fuchs Pentosin EG FFL-7A	41 %	35 %
Automotive racing gear oil	55 %	40 %

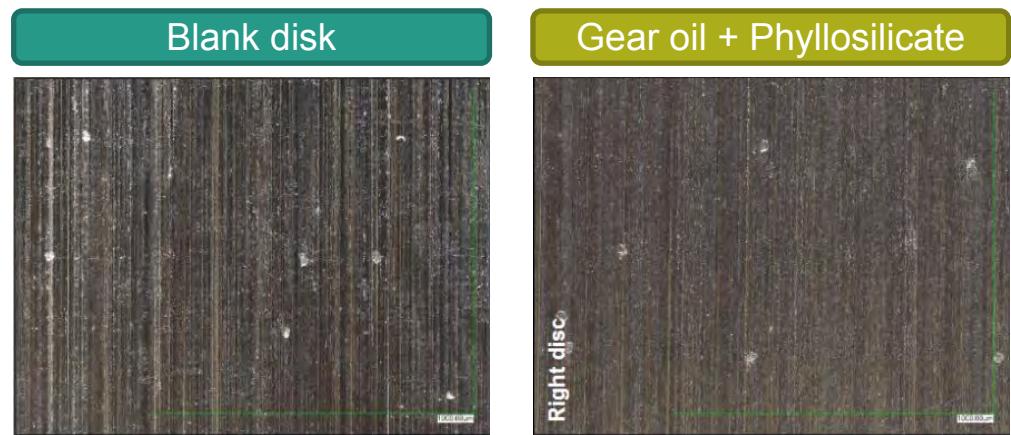
2-Disk surface roughness:
Ra reduced by 34 % / Rz reduced by 40 %

$Ra = 0.30 \mu\text{m}$
 $Rz = 2.70 \mu\text{m}$

$Ra = 0.20 \mu\text{m}$
 $Rz = 1.62 \mu\text{m}$

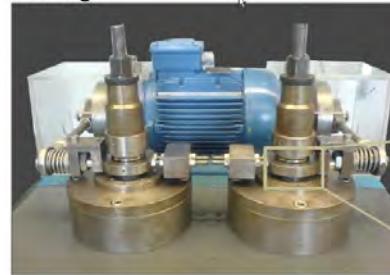
Test Rig

False-Brinelling Test – For Pitch Bearing Evaluation

Frequency: 25 Hz

Oszillation angle:

+/- 0.5° -> +/- 3.0°

Axial load:

3 kN to 4 balls (750 N per ball)

Test bearing: ARKL Type 51206 with 4 rolling elements

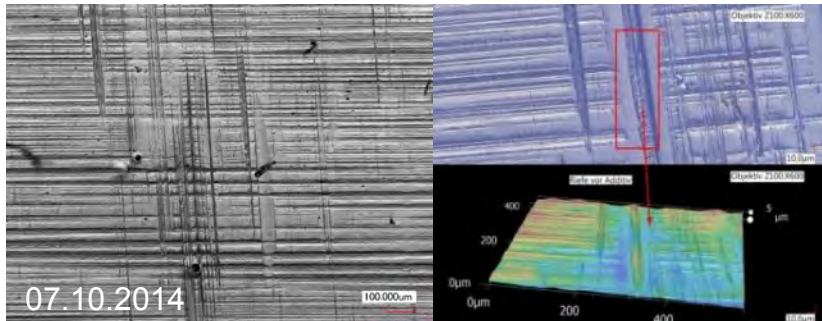
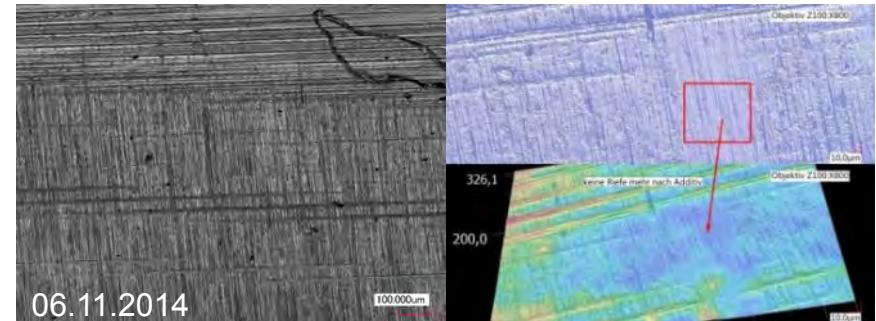
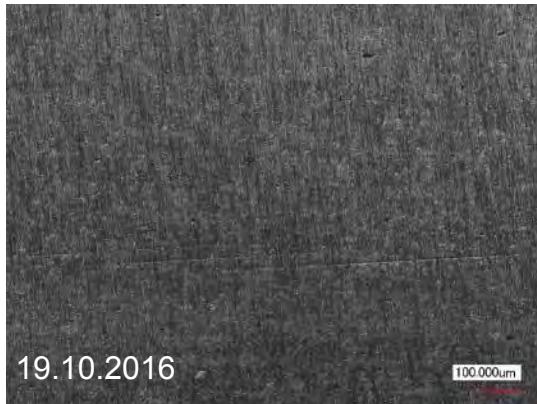
GE 1.5 MW Wind Turbine Gearbox

- Wear development on a Bosch Rexroth gear tooth (GE 1.5 SL) over a period of two years

- Run through marks on the tooth flank after 6 weeks and 2 years:
 - Reduction of the surface roughness and friction force
 - Improved load carrying capacity
 - Less stress for the tooth flank

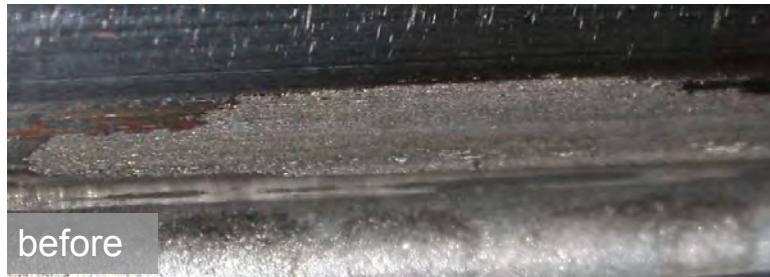
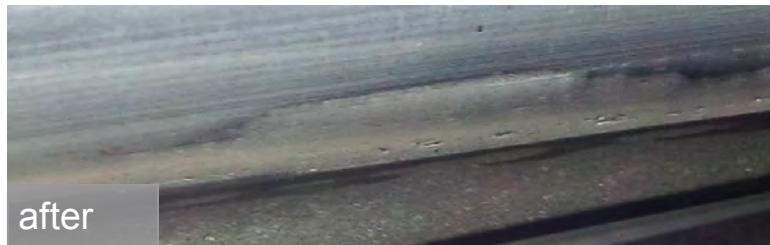
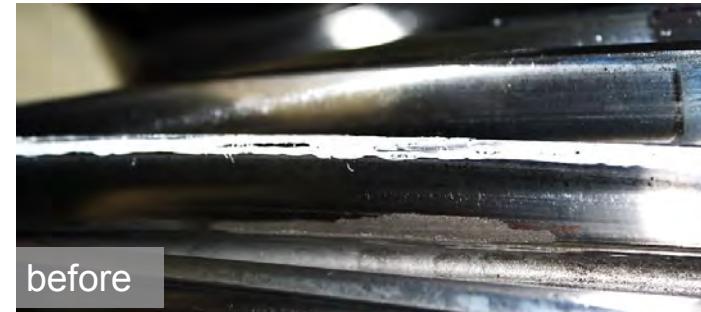
Example of a Gearbox Application

- Gearbox CSIC 2 MW VSCF

- Significant operational wear visible
- In the foot area visible micro pitting
- Oxidation visible

- Operational wear noticeable reduced
- Reduction of micro pitting
- The contact pattern is optimized

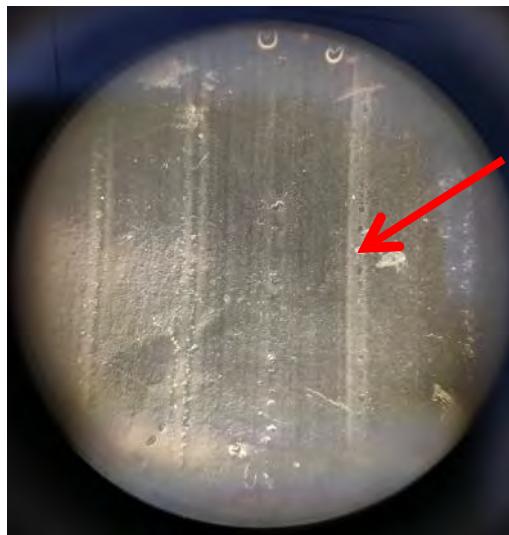
Picture: Before wind turbine was treated

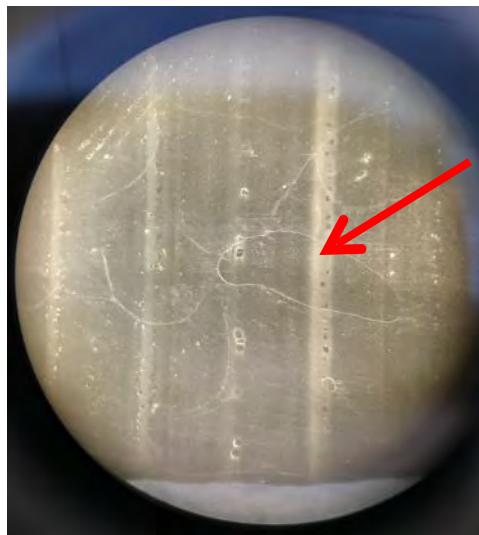
Picture: **5 months** after wind turbine was treated with additive

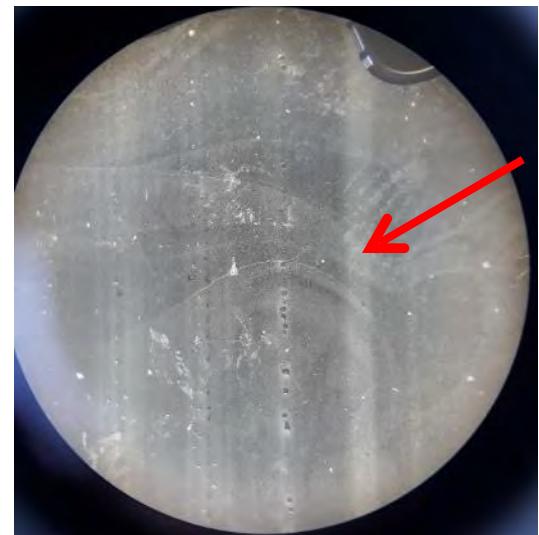
Picture: **12 months** after wind turbine was treated with additive

Red arrow shows the same right track on the surface imprint

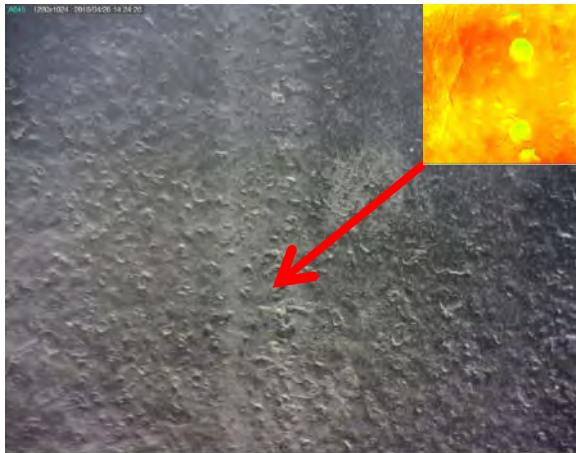
Picture: Before wind turbine was treated

$R_a = 0,556 \mu\text{m}$ (within the track)

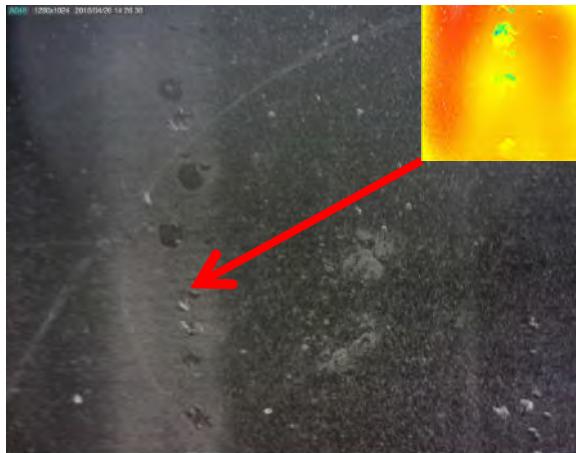
Picture: 5 months after wind turbine was treated with additive

$R_a = 0,403 \mu\text{m}$ (within the track)

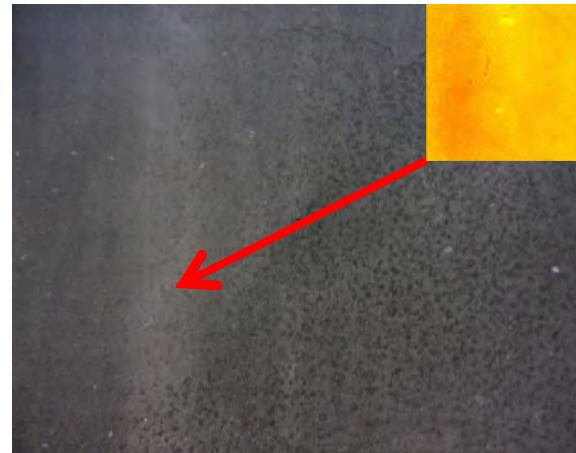
Picture: 12 months after wind turbine was treated with additive

$R_a = 0,225 \mu\text{m}$ (within the track)

Red arrow shows the same right track on the surface imprint

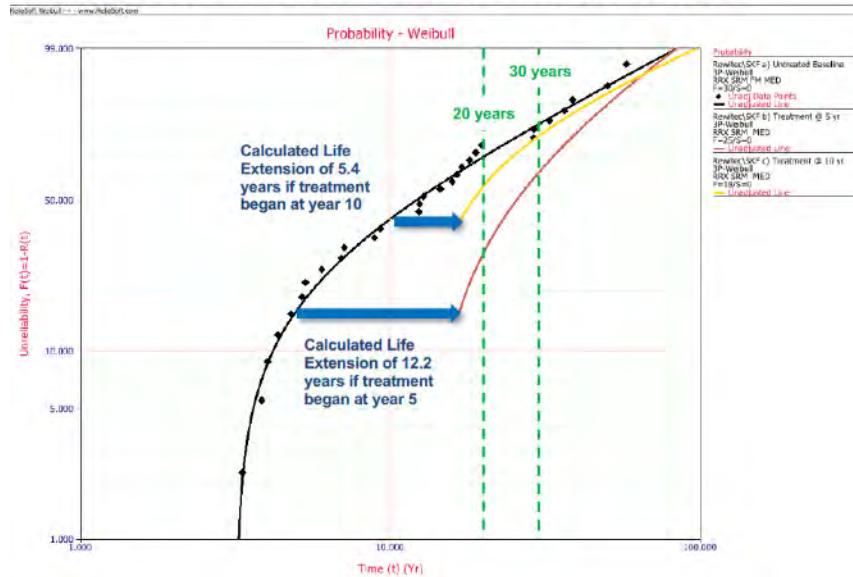
Acciona AW1500 Generator Side Mainshaft bearing – SKF 23188

Calculated life extension of upto 17 Years

Significant reduction in the probability of failure of a main bearing post application

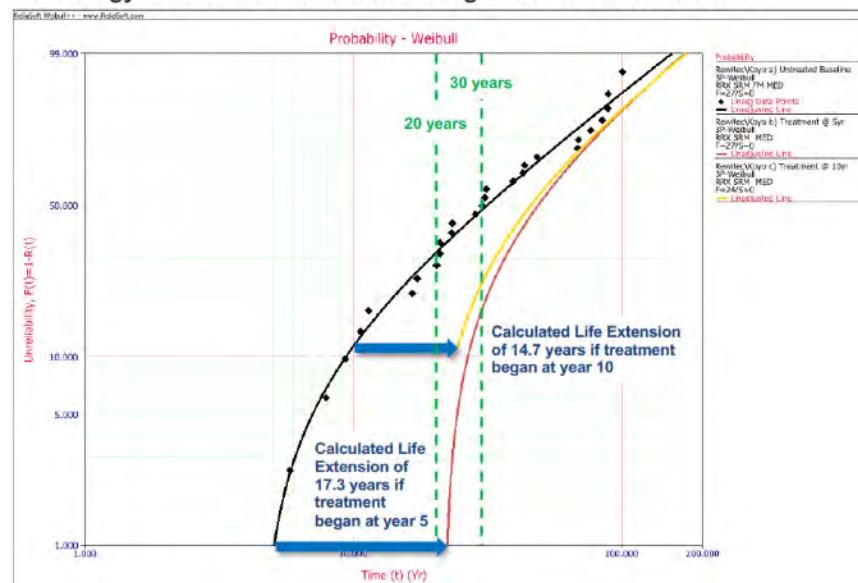
GE Energy 1.6/1.7-100 Mainshaft bearing – KOYO Model 240/710

The earlier the application, the greater the lifetime extension
